# Your survey report

Fishguard & Goodwick Urban  
District Council, Town Hall, Market  
Square, Fishguard,  
Pembrokeshire, SA65 9HE

4th February 2026

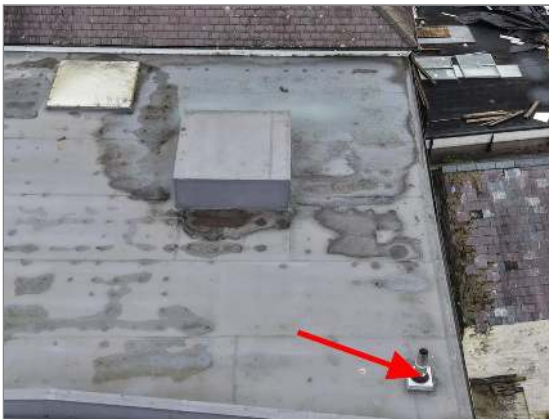
Photo - 3

There are no chimney stacks to the property, however, there is a stainless steel twin walled flue pipe with terminal which is for the gas fired central heating boiler located in the Plant Room which passes through the flat roof.

This appears in satisfactory condition but normal maintenance will be required.

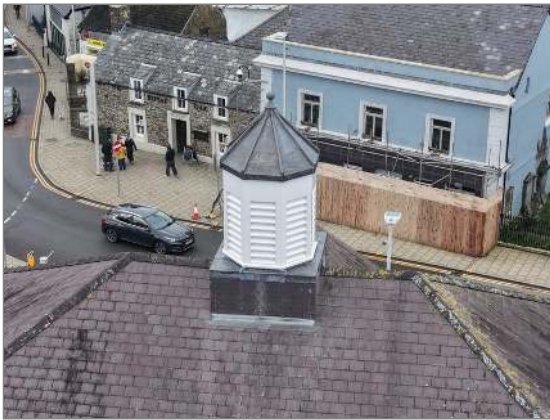
We are informed that the roof has recently been stripped and recovered with the original slate. The roof coverings are in sound condition with no urgent repairs required.

We are informed that recent repairs have been carried out to the bell tower. It was in satisfactory condition at the time of inspection.

*Photo - 4 Original hipped roof and Bell Tower type structure*

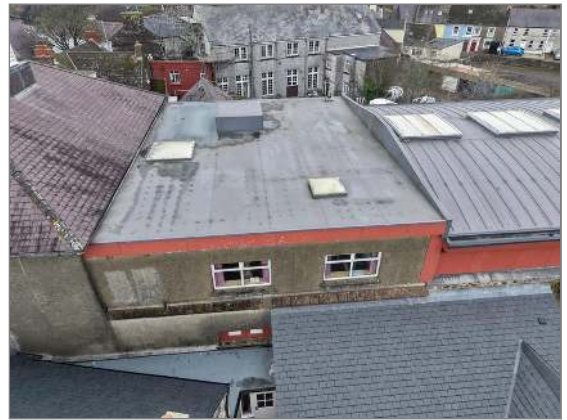
The rubber membrane type covering was inspected with the aid of a drone which showed numerous water ponding stains and also collection of water to the front left hand side. Fixing details are also protruding through the GRP covering which are likely to affect the life span.

*Photo - 5 Flat roof to interconnecting structure.*

Flat roofs will have a limited life, we recommend that further enquiries are made to establish whether a guarantee is available for the roof and if so, it can be transferred to yourself.

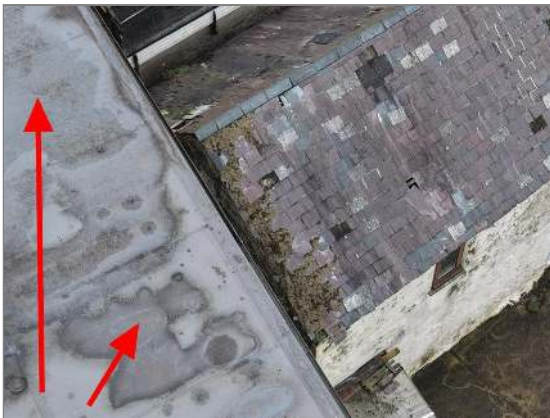
Clearly there are visible problems with the covering due to the excessive ponding and water staining noted at the time of inspection. The perspex covering to the sky light is likely to perish due to UV rays from the sun light and we recommend that these are checked.

*Photo - 6 Ponding to flat roof.*

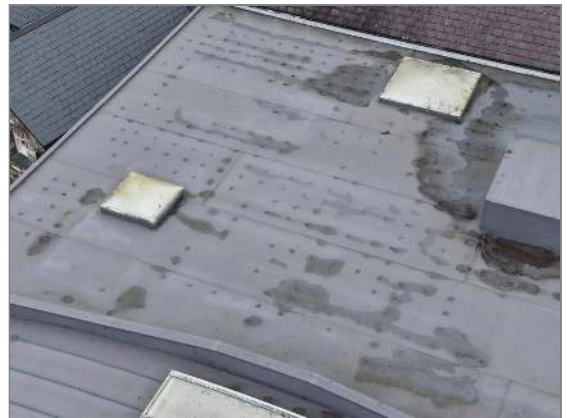
The membrane covering appears in reasonable condition although circular fixing patches were visible and these are likely to fail and could cause leaks. This type of covering will have a limited life.

*Photo - 7 Circular fixing and ponding.*

We recommend further enquiries are made to see whether a guarantee is available for the coverings as this is likely to have a limited life.

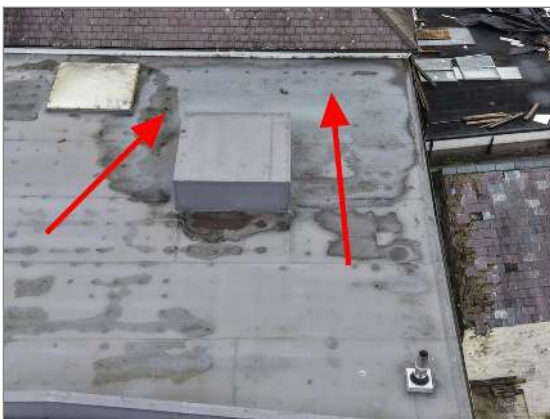
*Photo - 8 Ponding to corner and around raised structure.*

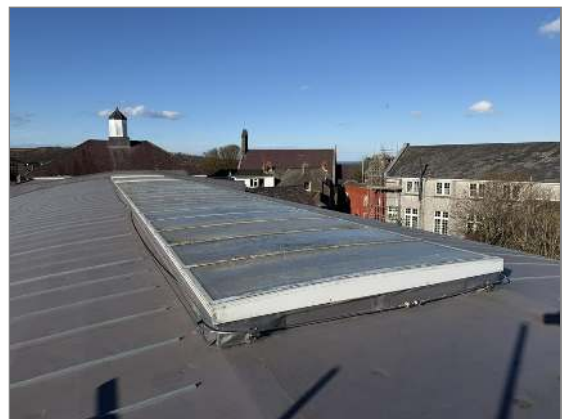
The rubber membrane covering appears in reasonable condition, however, the raised central perspex sky light detail is in generally poor condition. Internally, there are water stains showing from leaks to the detail and externally significant staining is noted. We believe that this detail is cracking due to the UV rays from the sun and is likely to require replacement.

*Photo - 9 Perplex sky lights to market hall.*

The raised perspex sky light detail is not considered to be satisfactory and we recommend that this is replaced with a new system which will reduce the risk of leaks/water ingress.

Replacing the sky light is likely to be more practical than trying to repair existing as the existing design is not considered suitable. A new alternative should be considered which will reduce future maintenance costs.

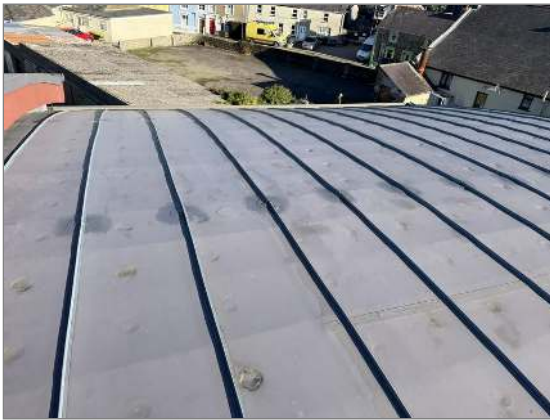
The rubber membrane type covering appears in reasonable condition but some of the aluminium rails were loose and will need to be refixed. Flashing detail to parapet wall between the dome shaped roof and the flat roof which is covered with metal powder coated detail and rubber membrane covering.

Photo - 10 Aluminium guide rails.

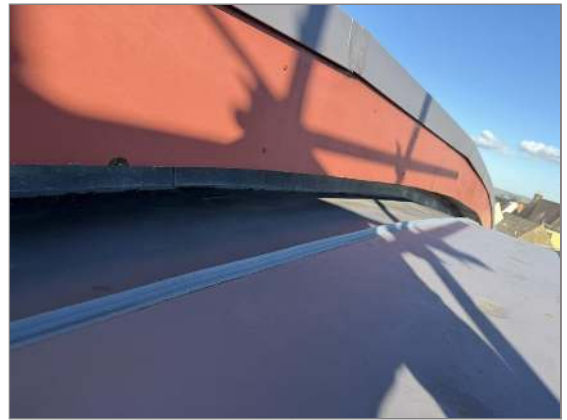
Photo - 11 Flashing/abutment detail for extension roof.

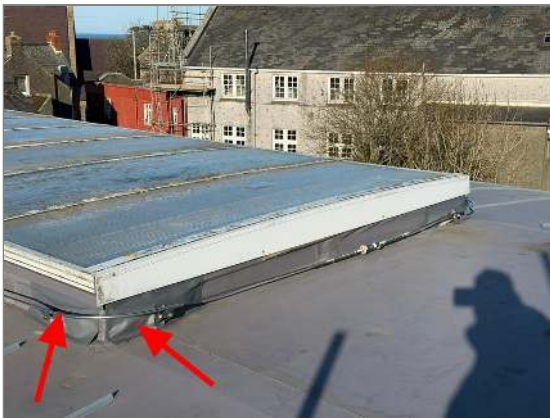
Very poor flashing detail around the main sky light structure, thick cable detail around the upstand detail with tape type flashing to join of fixing bracket to corners, this is likely to cause an area where moisture ingress will occur into the structure. (See photo)

Photo - 12 Poor flashing detail around raised perspex sky lights.

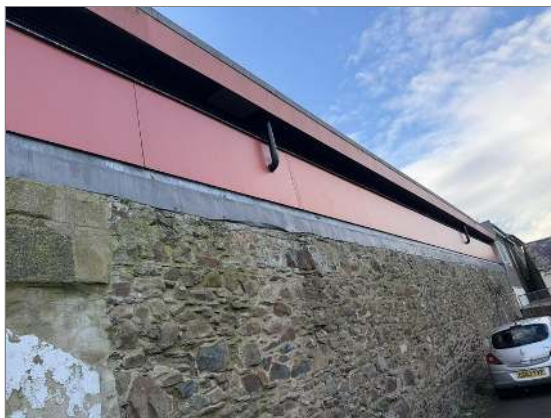
*Photo - 13 Lead detail to join where market hall building extended upwards.*

It is important that any lead abutment details to the cavity walls are kept in good condition in order to prevent moisture ingress.

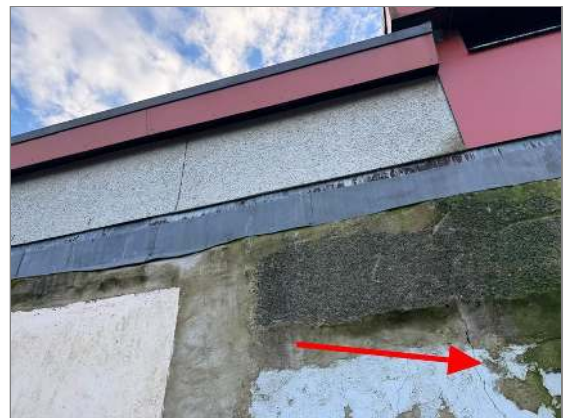
Traditional cavity block walls to the attached extension to rear with roughcast rendered elevation which has not been painted. Vertical expansion crack to rear. The render extend down to the ground.

*Photo - 14 Rendered section to extension and lead detail to join. Crack in render to join.*

We recommend that the render should be cut back from the ground as this can cause moisture to rise and bridge the damp proof course.

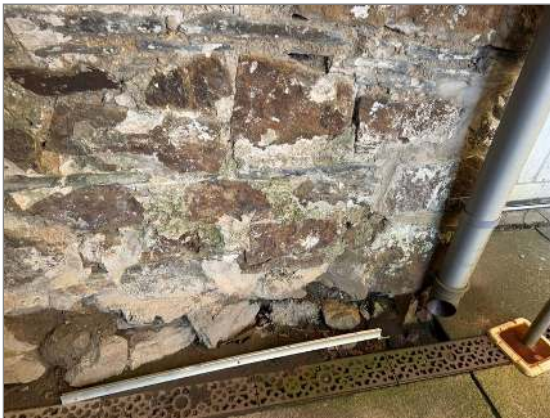
*Photo - 15 Repointing works to stone wall to rear of market hall, especially at low level.*

| Repairs | Cost guidance (optional) |
|---|---|
| D4 – Main walls – Repoint stone wall to rear and repair cracks. | |

You now need to instruct a contractor to carry out repointing works to the exposed stone work to the rear elevation which is allowing moisture into the building.

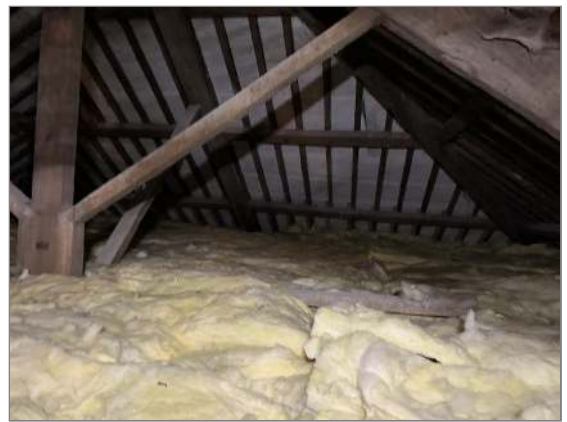
*Photo - 17 Well insulated roof space which prevents access*

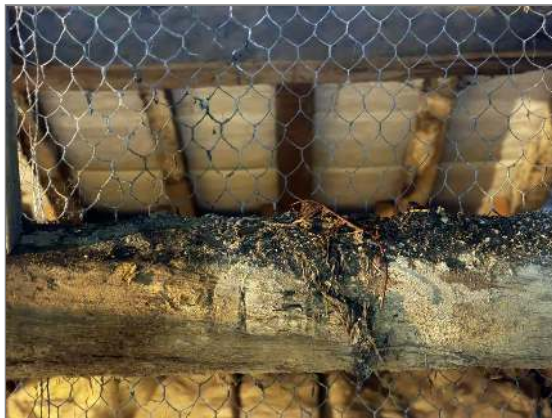
Where original timbers are still present there is a risk of wood boring insect infestation, rot and decay, especially to concealed timbers. During our inspection we noted that some timbers are being affected by wood boring insect infestation, rot and decay. You should now employ a specialist contractor to treat the timbers around the property. This should be covered by a guarantee.

*Photo - 18 Active wood boring infestation and softening of the timbers*

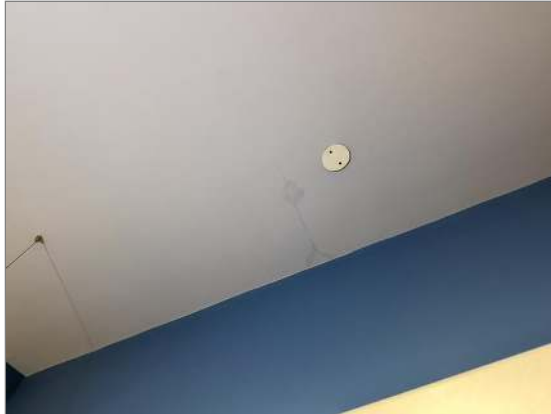
*Photo - 21 Stains to tapestry ceiling*

| Repairs | Cost guidance (optional) |
|---|---|
| E2 – Ceilings - Repair/redecorate damp stained ceilings. | |

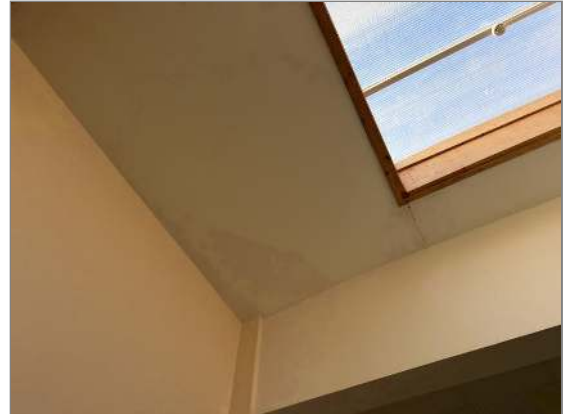
One of the biggest concerns is the condition of the perspex sky light roofing system to the domed/curved roof to the Market Hall Building. This is currently leaking and we believe that the existing system of perspex is not suitable for this type of structure. A new sky light system should be installed which should comprise of insulated toughened glass, this glazing would be more efficient in retaining heat and is less likely to leak. The existing perspex material has perished in some areas which has caused cracks and this is likely to get worse, furthermore, it does not offer good insulating properties.

*Photo - 22 Stains to domed roof*

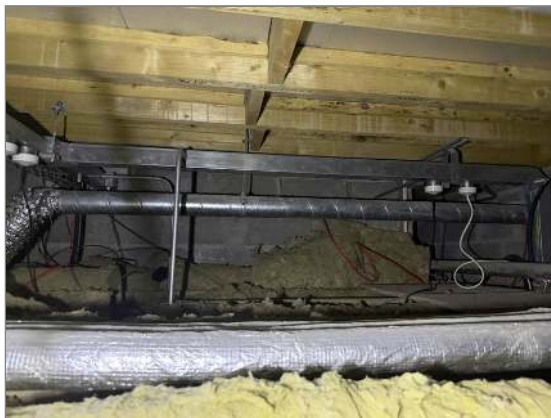
*Photo - 23 Voids over WC's*

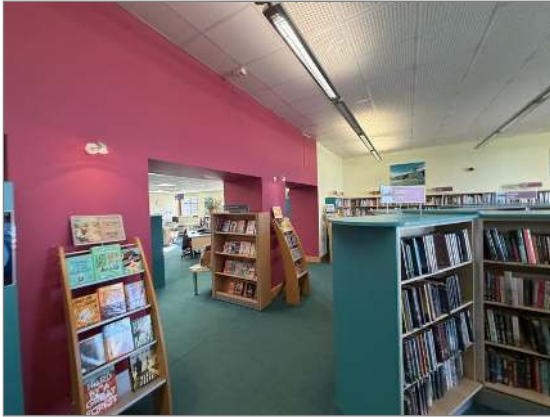
*Photo - 24 Parts of the rear original wall has been taken down*

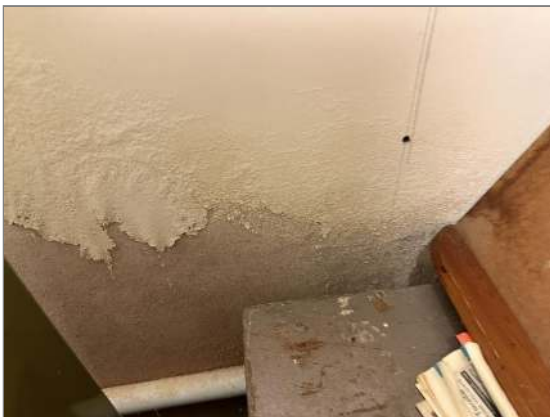
*Photo - 26 Obvious damp issues to room off clerk office*

| Repairs | Cost guidance (optional) |
|---|---|
| E3 – Walls and Partitions - Replace damp affected plaster. | |

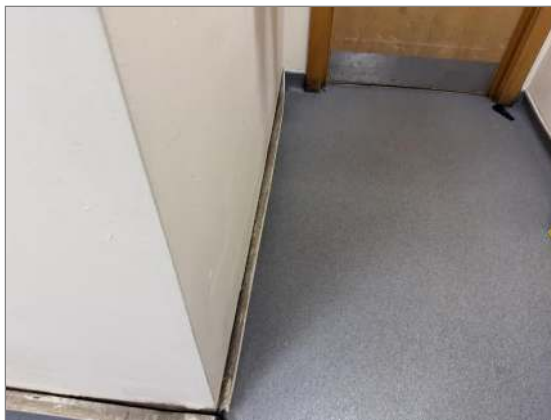
*Photo - 27 Loose floor covering in the kitchen*

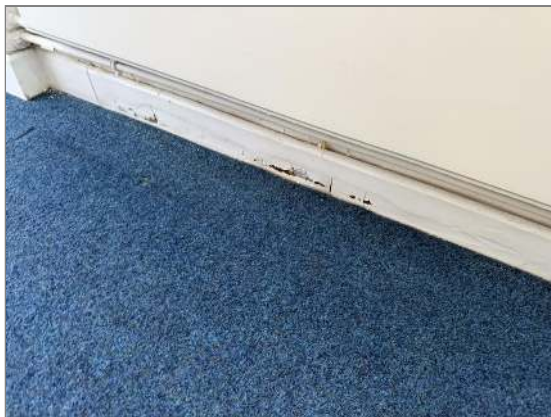
Dry rot can be very destructive and can be costly to resolve. Especially in a building of this size.

*Photo - 28 Cuboidal cracking to skirting - indicating potential dry rot*

| Repairs | Cost guidance (optional) |
|---|---|
| E7 – Woodwork - Replace rot affected woodwork. | |
